4.0 DAM MAINTENANCE AND REPAIR

4.1 OVERVIEW

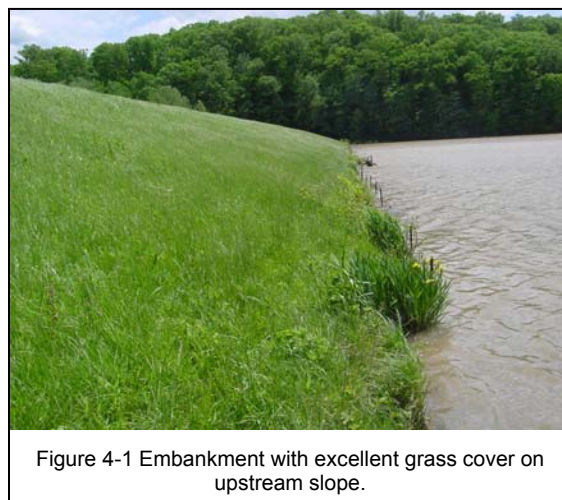
Figure 4-1 Embankment with excellent grass cover on upstream slope.

Grass vegetation is an effective and inexpensive way to prevent erosion of embankment surfaces. Grass is the only vegetation that is recommended for use on dam embankments. If properly maintained, it also enhances the appearance of the dam and provides a surface that can be easily inspected. Roots and stems tend to trap fine sand and soil particles, forming an erosion resistant layer once the plants are well established. Grass vegetation is least effective in areas of concentrated runoff, such as the contact of the embankment and abutments, or in areas subjected to wave action. Types of grass vegetation that have been used on dams in Indiana are fescue, rye grass, bluegrass, Bermuda grass, brome and reed canary grass. Sericea Lespedeza and crown vetch are not recommended in the spillway or on the dam embankment. IDNR permission may be required to use tall fescue.

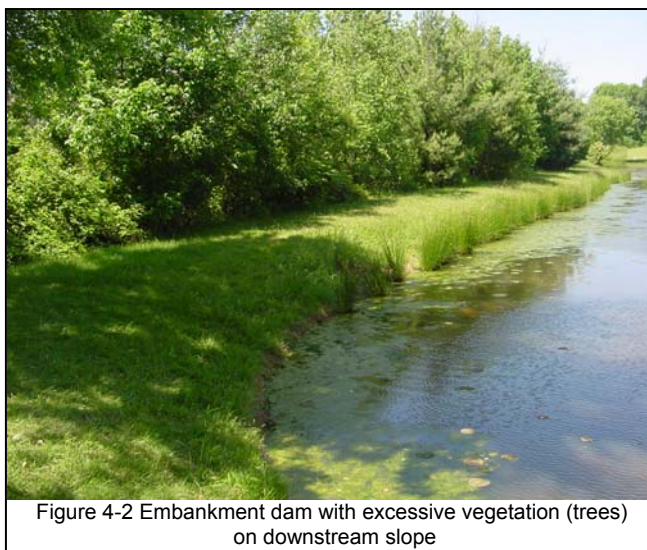
Figure 4-2 Embankment dam with excessive vegetation (trees) on downstream slope

Trees and brush should not be permitted on embankment surfaces or in vegetated earth spillways. Extensive root systems can provide seepage paths for water. Trees that blow down or fall over can leave large holes in the embankment surface that will weaken the embankment and can lead to increased erosion or dam breaching. Trees and brush obscure the surface limiting visual inspection, provides a haven for burrowing animals, and retards growth of grass vegetation. Tree and brush growth adjacent to concrete walls and structures may eventually cause damage and should be removed. Some root systems can decay and rot, providing passageways for water, and thus cause erosion. Growing root systems can lift concrete slabs or structures, and can penetrate and damage drain systems. Trees and brush that are within 25 feet of the dam should be removed.

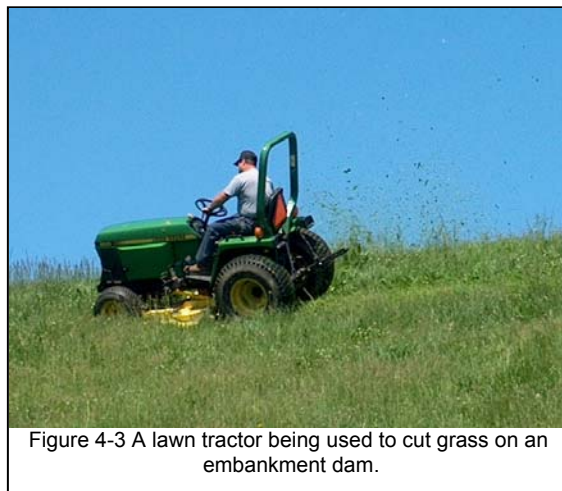
garden and farm tractors described in this manual cannot be used safely on slopes steeper than 2.5H:1V (40% or 21.80-degree slope). The larger tractors should be obtained with the lowest profile (or center of gravity) necessary for the type of slope to be mowed. Dual wheels or wider tires can be used to increase stability. All of these units should be equipped with safety roll bars designed to support the full weight of the tractor.

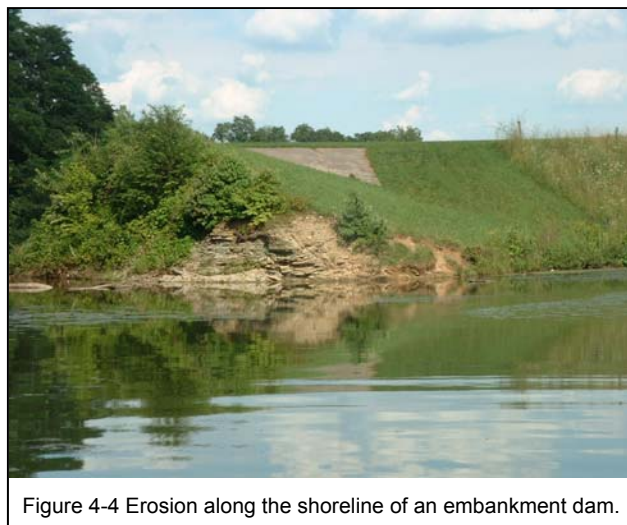
Figure 4-4 Erosion along the shoreline of an embankment dam.

A serious erosion problem which can develop on the upstream slope is "beaching." Waves caused by high winds or high-speed power boats can erode the exposed face of the embankment. Waves repeatedly strike the surface just above the pool elevation, rush up the slope, then tumble downward into the pool. This action erodes material from the face of the embankment and displaces it farther down the slope, creating a "beach". Erosion of unprotected soil can be rapid and during a severe storm could lead to complete failure of a dam. The upstream face of a dam is commonly protected against wave erosion and the resultant beaching by placement of a layer of rock riprap over a layer of filter material. In some cases other materials such as steel, bituminous or concrete facing, bricks or concrete blocks are used. Generally, rock riprap provides the most economical protection.

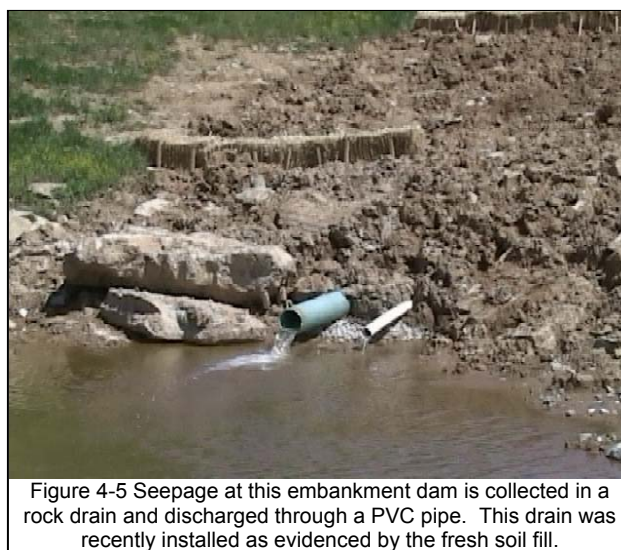
Figure 4-5 Seepage at this embankment dam is collected in a rock drain and discharged through a PVC pipe. This drain was recently installed as evidenced by the fresh soil fill.

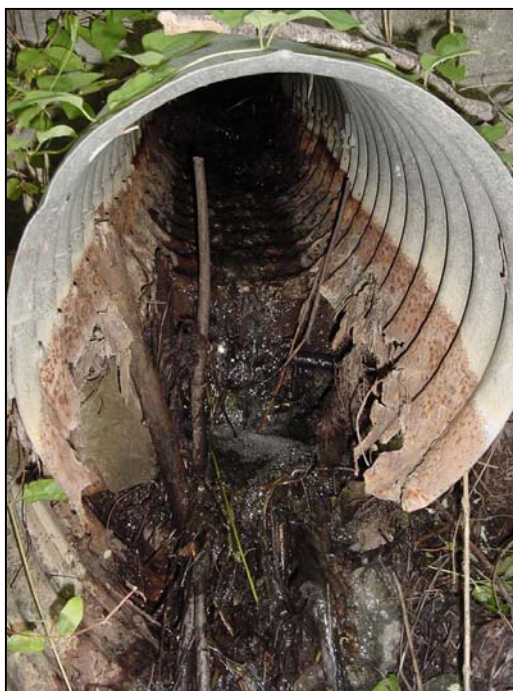
Figure 4-6 This corrugated metal pipe is completely rusted through on the bottom, creating a safety concern. Metal pipes are not recommended for use in dams.

Frequent inspection is necessary to ensure the spillway conduit is functioning properly. All conduits should be inspected thoroughly once a year. Conduits which are 30 inches or more in diameter can be entered and visually inspected. The conduits should be inspected for improper alignment (sagging), separation and displacement at joints, cracks, leaks, surface wear, loss of protective coatings, corrosion, and blockage.

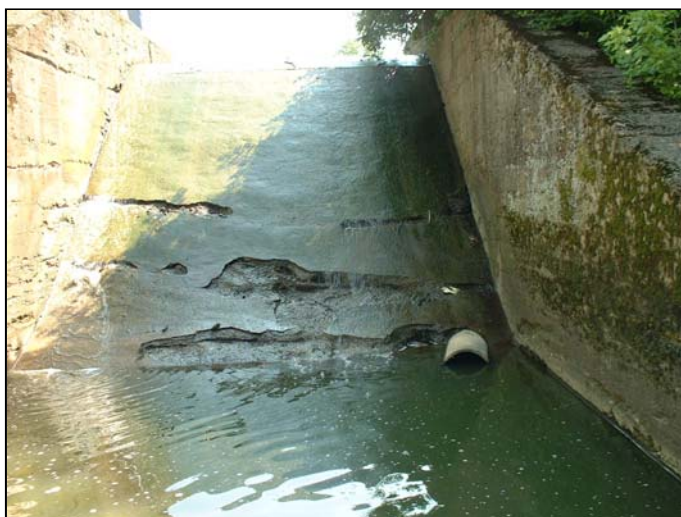
Figure 4-9 The floor and side walls of this concrete spillway are badly deteriorated and in need of repair.

Maintenance of concrete spillways should include keeping the channel clear of debris, filling joints and cracks, keeping underdrains open and maintaining the structural stability of the concrete. Concrete spillways must be inspected for cracks or

displacements caused by settlement, foundation failure, uncontrolled seepage, and frost action. Voids created by the settlement of compressible soils beneath spillways and uncontrolled seepage may cause the concrete to crack or displace due to lack of support. When temperatures fall below the freezing point, water located in the soil voids begins to freeze. Ice lenses can form and cause the concrete to crack and displace by a mechanism known as "frost heave." It is important to provide adequate drainage for concrete located on soil. Drains under concrete must be kept clear. Clogged or plugged drains, and inadequate filter systems can cause saturated conditions beneath the concrete. More information on concrete rehabilitation and seepage is contained in the subchapter on Concrete Repair.

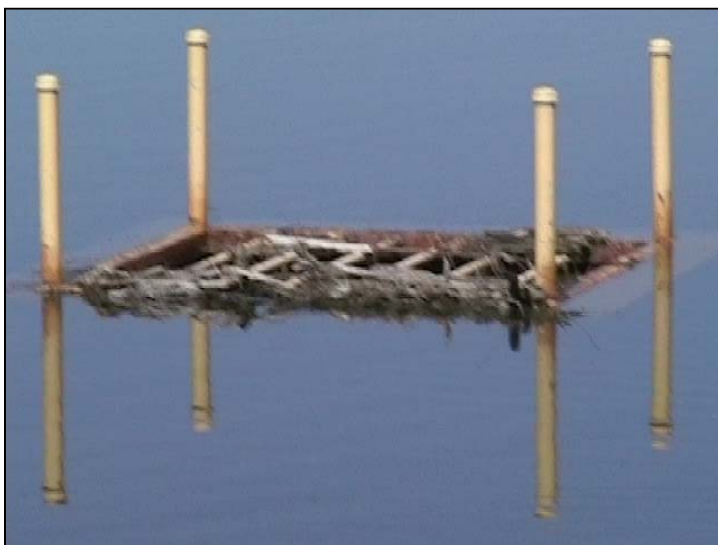
Figure 4-10 This is an example of a bad trash rack design. Trash racks should not be designed or constructed to be one-dimensional (flat, flush with water surface); this design almost guarantees clogging.

A well-designed trash rack will stop large debris that could plug the pipe but allow unrestricted passage of water and smaller debris. Some of the most effective trash racks allow flow to pass beneath the trash rack into the riser inlet as the pool level rises. Trash racks usually become plugged because the openings are too small or the head loss at the rack causes material and sediment to settle and accumulate. Small openings will stop small debris such as twigs and leaves, which in turn cause a progression of larger items to build up, eventually blocking the inlet. Trash rack openings should be at least 6 inches across regardless of the pipe size. The larger the principal spillway conduit, the larger the trash rack opening should be. The largest possible openings should be used, up to a maximum of about 12 inches.

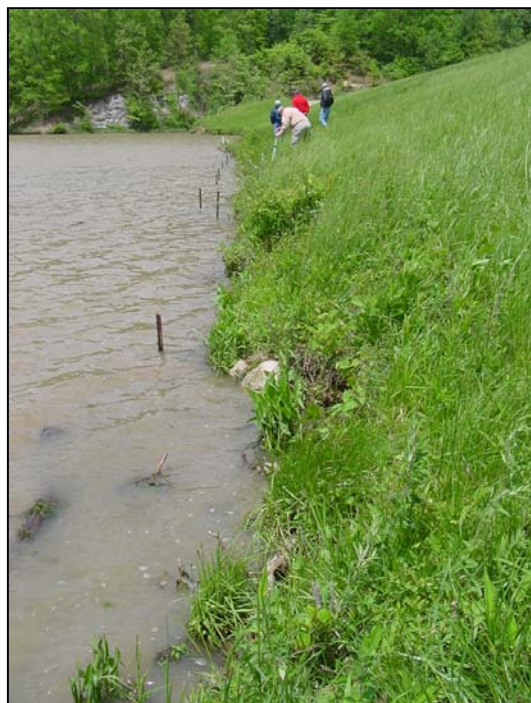
Figure 4-11 Embankment dam exhibiting minor shoreline erosion.

A serious erosion problem called "beaching" can develop on the upstream slope of a dam as discussed earlier. The upstream face of a dam is commonly protected against wave erosion and resultant beaching by placement on the face of a layer of rock riprap over a layer of filter material. Sometimes, materials such as steel, bituminous or concrete facing, bricks, or concrete blocks are used for this upstream slope protection. Protective beaches are sometimes actually built into small dams by placing a berm (8 to 10 feet wide) along the upstream face a short distance below the normal pool level thereby providing a surface on which wave energy can dissipate. Generally, however, rock riprap provides the most economical and effective protection.

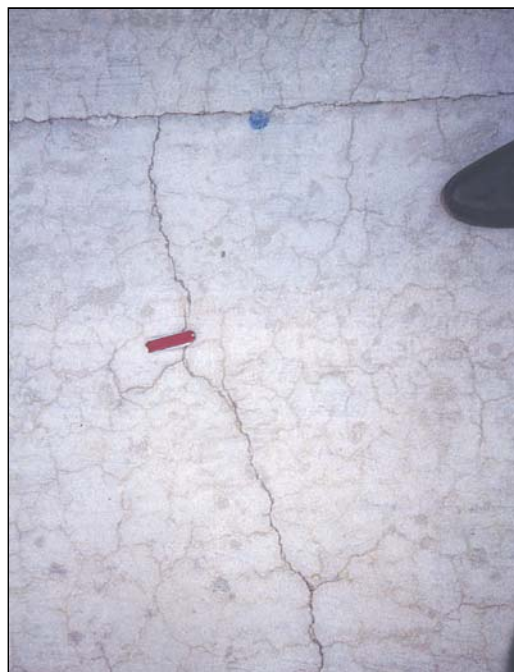
Figure 4-12 A large reflective crack has formed in a concrete overlay which also exhibits circular drying shrinkage cracking.
